# Manhole Inspection Summary

Manhole # S57M\_\_023MH

Insp Date: **7/2/08 2:01 PM**

**Location** Address: **3901 dillon st**

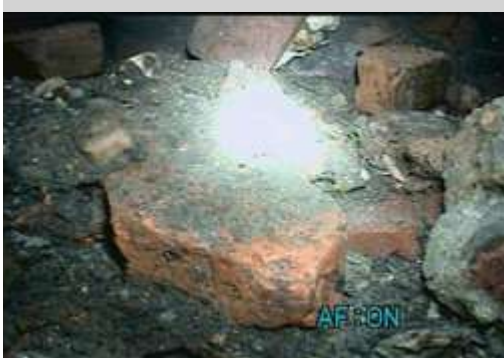
Defect 5

Condition: ☐ Sound ☐ Cracked ☐ Root Intrusion ☐ Deteriorated ☐ Leaks ☒ **Debris**

bench debris

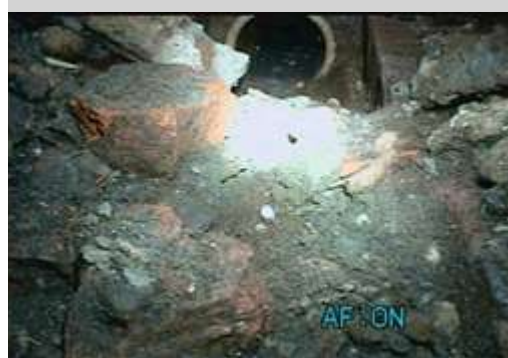
Defect 4

Condition: ☐ Sound ☐ Cracked ☐ Root Intrusion ☐ Deteriorated ☐ Leaks ☒ **Debris**

channel debris

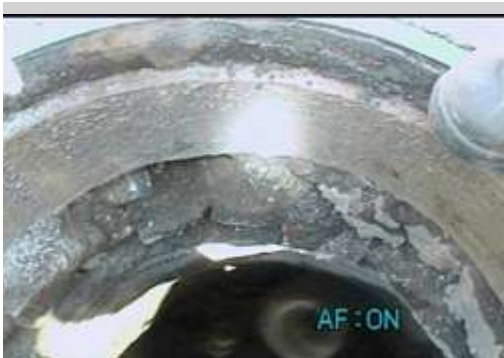
Defect 3

**Frame** Offset: **3** (in.) Condition: ☒ Sound ☐ Cracked ☐ Leaks

frame offset

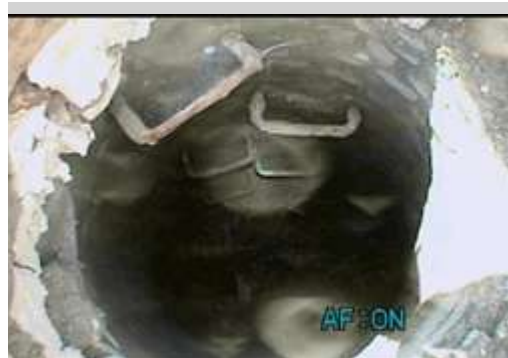
Defect 2

**Steps** Count: **5** Missing: **0** ☒ **Corroded**

corroded steps

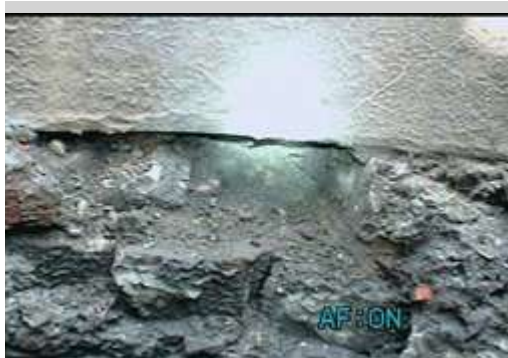
### Defect 1

Condition: ☐ Sound ☒ **Cracked** ☐ Root Intrusion ☒ **Loose Brick** ☐ Deteriorated

chimney loose bricks deteriorated frame  
adj
